NAUGATUCK RIVER BASIN  
PROSPECT, CONNECTICUT

**WATERBURY RESERVOIR NO.2 DAM  
CT 00304**

**PHASE I INSPECTION REPORT  
NATIONAL DAM INSPECTION PROGRAM**

SEPTEMBER 1980

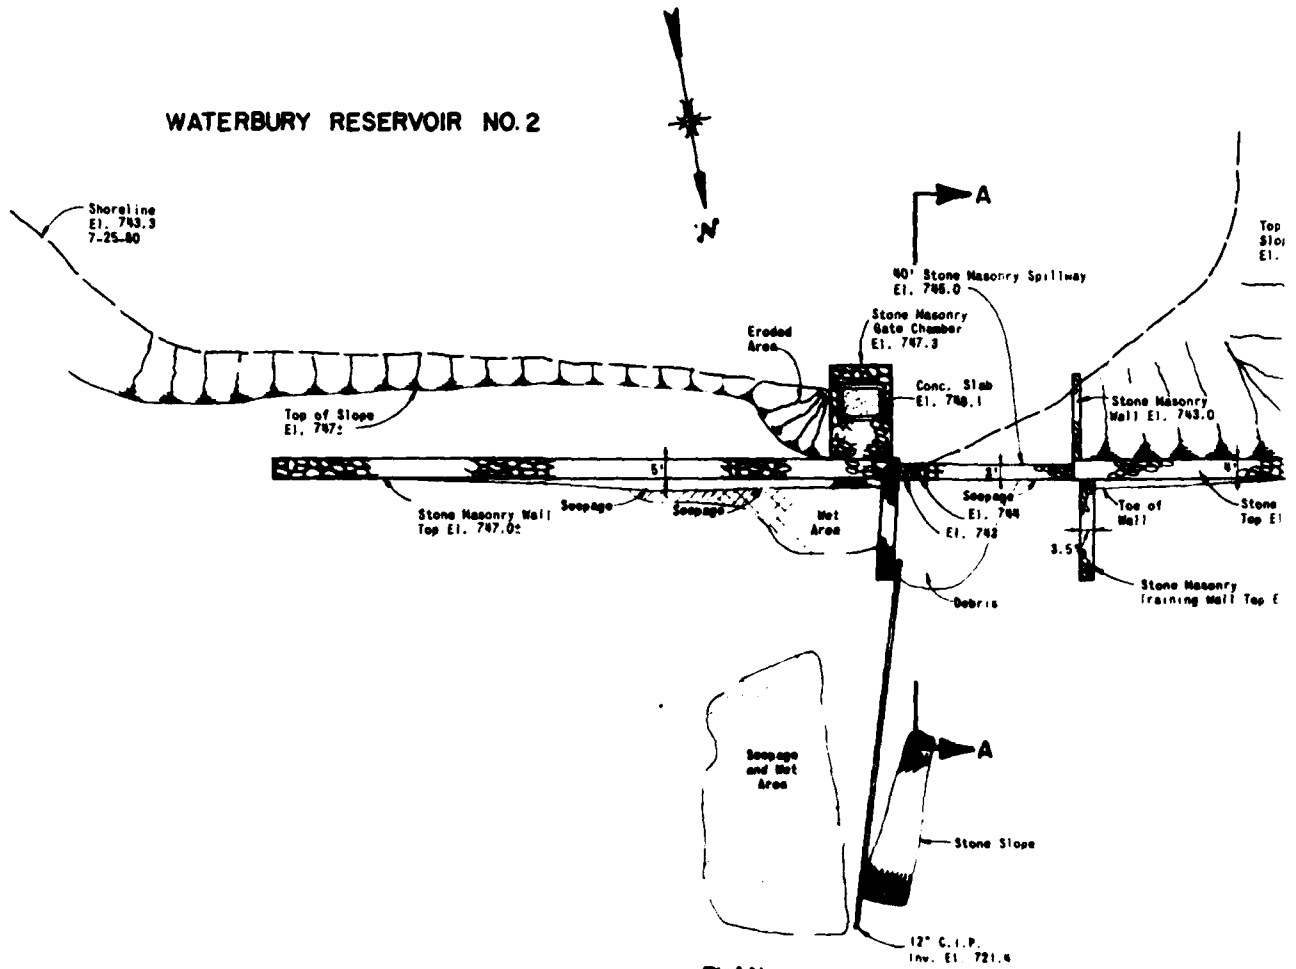
FIGURE 2

Seepage was also noted about 60 and about 100 feet downstream of the dam and to the right of the low level outlet or blow-off pipe. (See Figure 2, page B-1 in Appendix B.) The seepage occurred in areas where there appeared to be clusters of cobbles and small boulders. These seepage areas were also stained a rusty orange color.

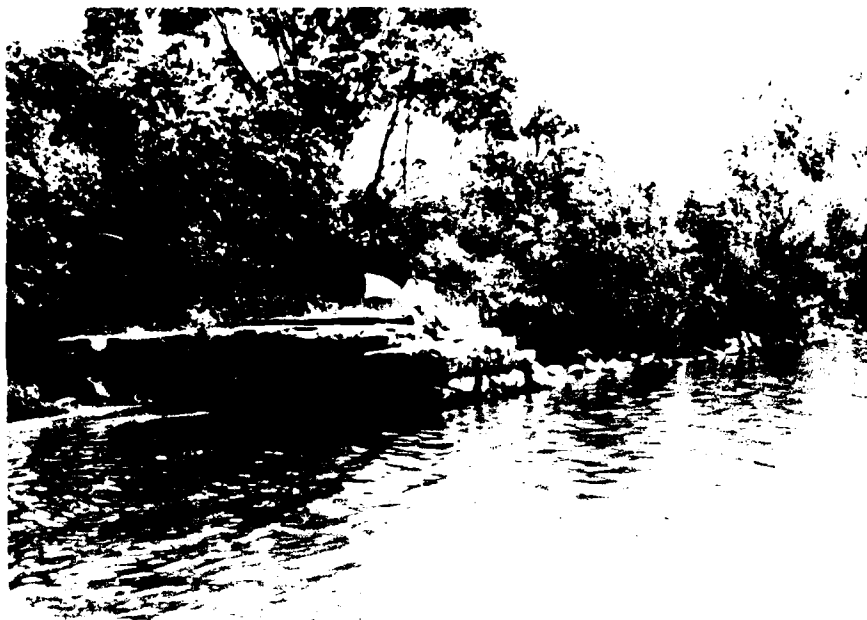
PHOTO NO. 1

UPSTREAM SLOPE FROM LEFT ABUTMENT.  
NOTE RIPRAP SLOPE PROTECTION, WEEDS AND GATE CHAMBER.

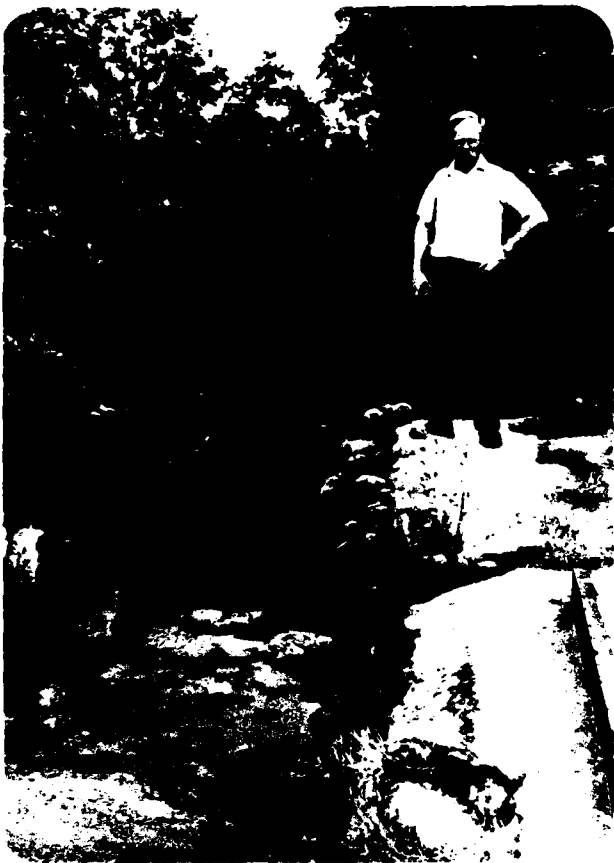
PHOTO NO. 7

The spillway crest is formed of mortared stone, with one or more stones missing at the right end, Photo 7. The spillway crest is very uneven and the mortar holding the remaining stone is broken and missing in some places. Portions of the crest are overgrown with weeds and brush.

3) Missing stones and deteriorated mortar in the spillway crest and downstream wall could lead to failure of the spillway and breaching of the dam.

MISSING STONES AT  
RIGHT END OF  
OVERFLOW SPILLWAY.

disintegration. Replacing the spillway stones is not recommended.
